**Re: Hazardous Materials Audit - Deakin University, Geelong Waterfront  
Campus, Western Beach Road, Geelong, VIC**

**Asbestos & Hazardous Materials Risk Assessment  
Deakin University**

**Deakin University, Geelong Waterfront Campus,  
Western Beach Road, Geelong, VIC**

# Asbestos & Hazardous Materials Risk Assessment

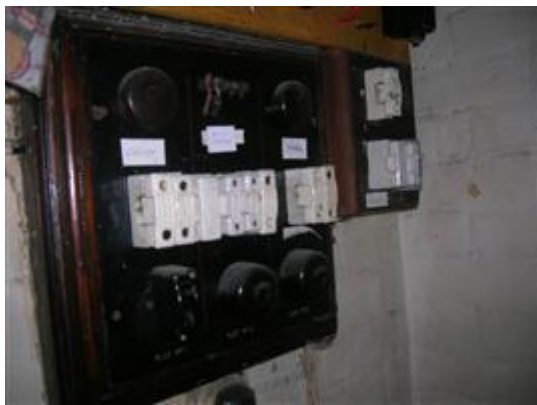
Photo No: Photo-00  
Feature: Switchboard backing  
Material: Compressed cement sheet  
Location: Western Beach Road; Building: 92-94;  
WESTERN BEACH ROAD - LEVEL 1; Room: BR.09  
Sample Reference: No Sample Taken  
Item Status: Assumed Positive

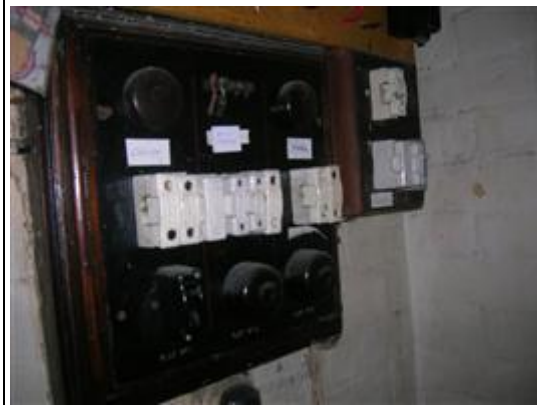
Photo No: Photo-11  
Feature: Switchboard backing  
Material: Millboard  
Location: Western Beach Road; Building: 92-94;  
WESTERN BEACH ROAD - LEVEL 1; Room: BR.09  
Sample Reference: No Sample Taken  
Item Status: Assumed Positive

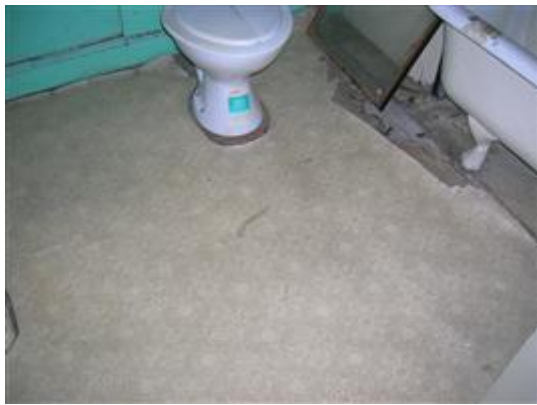
Photo No: Photo-05  
Feature: Floor covering  
Material: Millboard  
Location: Western Beach Road; Building: 92-94;  
WESTERN BEACH RD - LEVEL 2; Room: BR.19  
Sample Reference: 69311-8  
Item Status: Positive

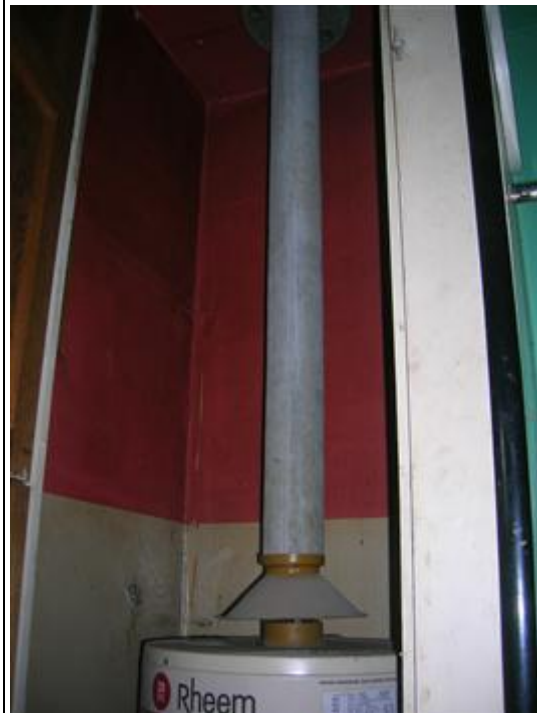
Photo No: Photo-04  
Feature: Hot water service  
Material: Moulded fibro cement flue  
Location: Western Beach Road; Building: 92-94;  
WESTERN BEACH RD - LEVEL 2; Room: BR.19  
Sample Reference: 69311-9  
Item Status: Positive

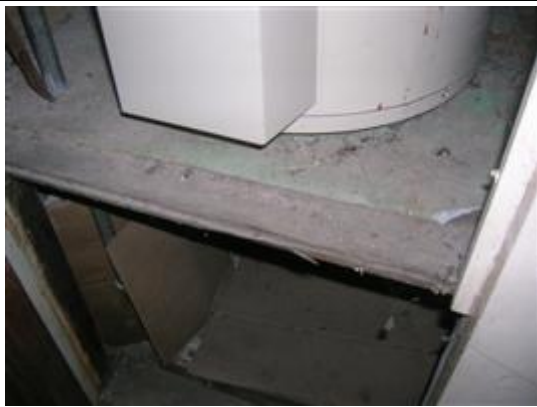
Photo No: Photo-03  
Feature: Hot water service  
Material: Compressed cement sheet  
Location: Western Beach Road; Building: 92-94;  
WESTERN BEACH RD - LEVEL 2; Room: BR.19  
Sample Reference: 69311-10  
Item Status: Positive

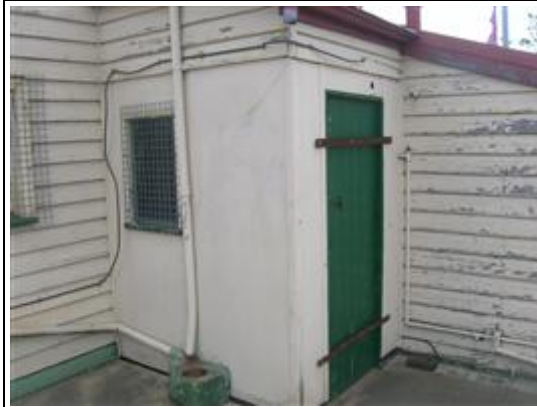
Photo No: Photo-07  
Feature: Wall  
Material: Flat cement sheet  
Location: Western Beach Road; Building: 92-94; Level:  
External; Room: External  
Sample Reference: 69311-12  
Item Status: Positive

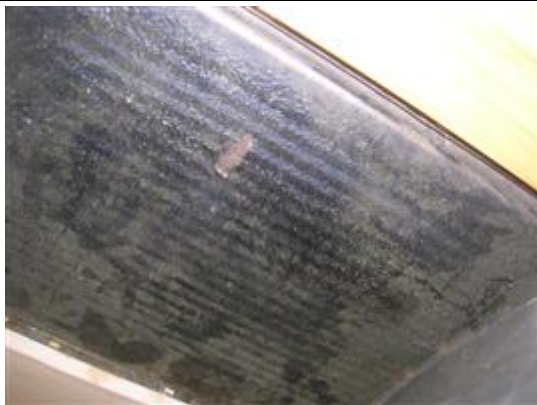
Photo No: Photo-10  
Feature: Waterproof membrane  
Material: Bituminous membrane  
Location: Western Beach Road; Building: DCP; LEVEL  
2; Room: C2.023  
Sample Reference: 69311-5  
Item Status: Positive

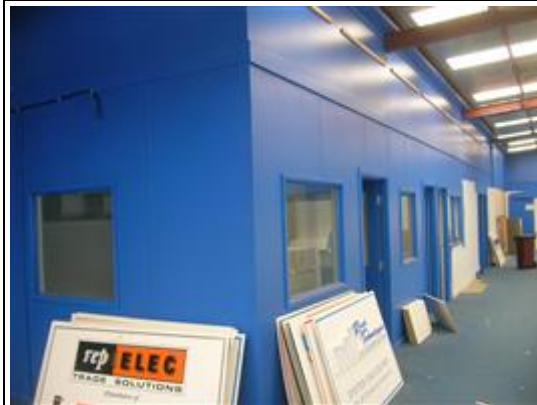
Photo No: Photo-13  
Feature: Wall  
Material: Flat cement sheet  
Location: Western Beach Road; Building: RX; LEVEL 1;  
Room: RX.01  
Sample Reference: 69311-14  
Item Status: Positive

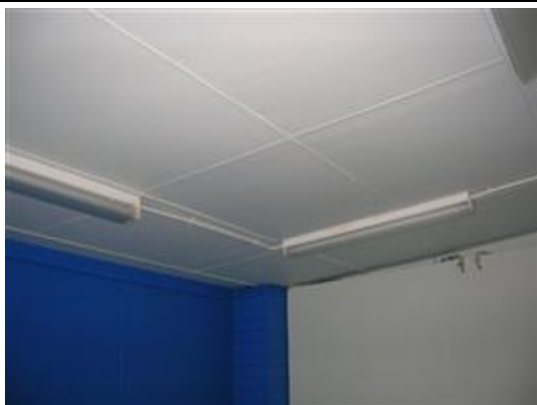
Photo No: Photo-12  
Feature: Ceiling  
Material: Flat cement sheet  
Location: Western Beach Road; Building: RX; LEVEL 1;  
Room: RX.02  
Sample Reference: 69311-13  
Item Status: Positive

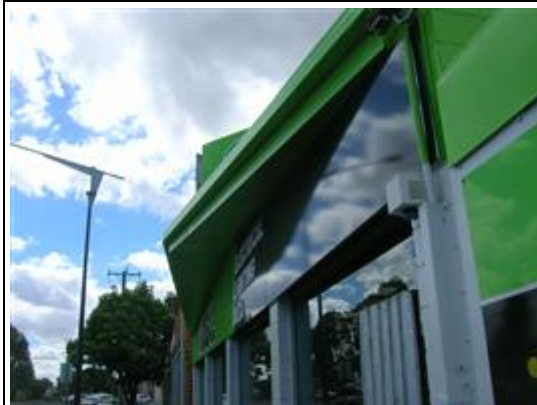
Photo No: Photo-16  
Feature: Porch Ceiling  
Material: Flat cement sheet  
Location: Western Beach Road; Building: RX; Level:  
External; Room: External  
Sample Reference: Similar To 69311-15  
Item Status: Assumed Positive

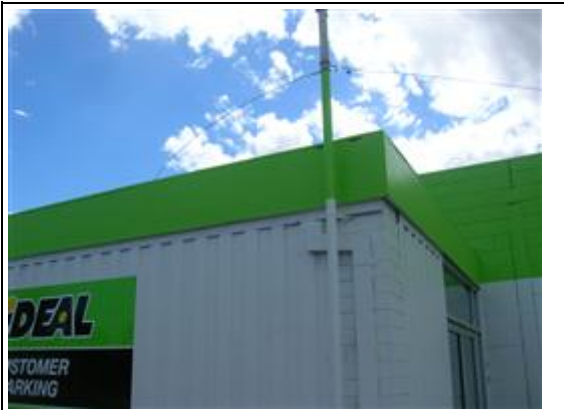
Photo No: Photo -15  
Feature: Fascia  
Material: Flat cement sheet  
Location: Western Beach Road; Building: RX; Level:  
External; Room: External  
Sample Reference: 69311-15  
Item Status: Positive
