Surface analysis of painted carbon fibre composites for automotive body panels – Results in progress

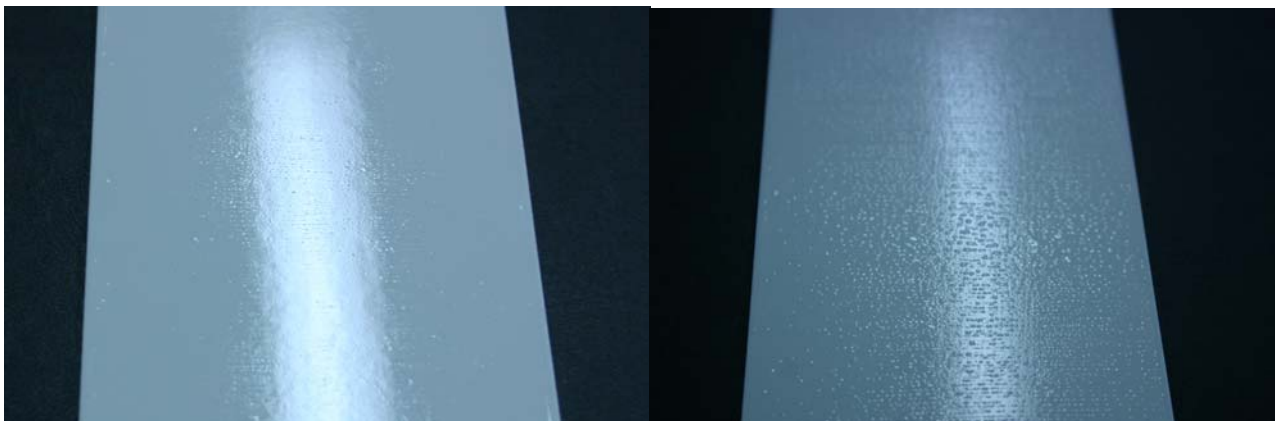
Figure 2. Painted unidirectional autoclave laminate submerged in water at 40°C after 1 week (left) and 5 weeks (right).

The Quickstep roughness results prior to painting had large error, with all surfaces rougher than autoclave. However, painting the surface covers the smaller irregularities, creating more consistent results, yet followed the same trend as the unpainted surface roughness values. Painted unidirectional laminates submerged in water at 40°C resulted in surface blisters occurring only for the autoclave laminates. The blisters occurred where the mould release water marks were present on the surface, however both Quickstep and autoclave laminates had the same treatment of mould release removal (Figure 2). Fibre print through occurs first on Quickstep twill surfaces when aged, however autoclave print through is delayed and eventually tends to be visibly worse.
